**Flood Control Project Maintenance
Levee Inspections**

Fall 2011 Levee Maintenance Deficiency Summary Report

San Joaquin River Basin

Reclamation District No. 0404 Boggs

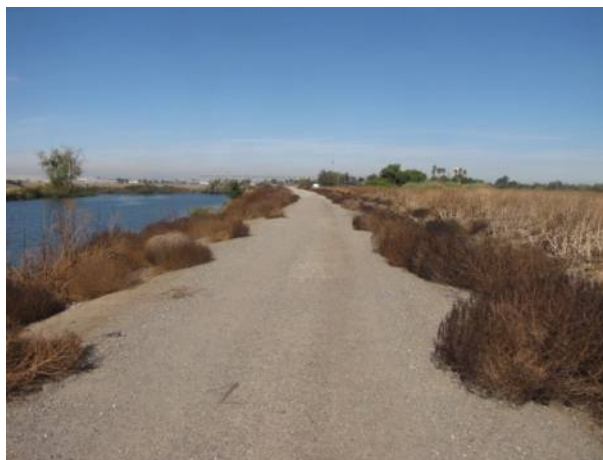
Levee Mile Report Line	1
Start Levee Mile	0.03
End Levee Mile	0.48
Location	Land Side
Category	Earthen Levee
Item	Vegetation

Looking north at modest vegetation on landside and waterside slopes.

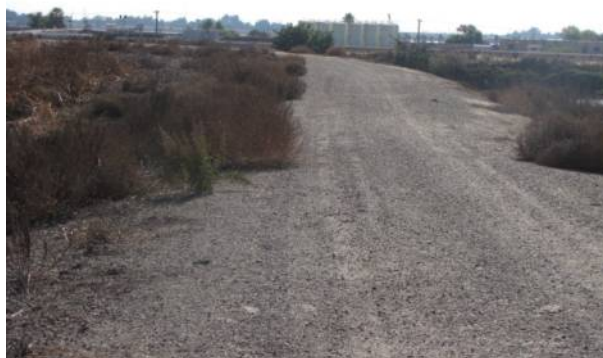
Levee Mile Report Line	2
Start Levee Mile	0.03
End Levee Mile	0.20
Location	Water Side
Category	Earthen Levee
Item	Vegetation

Looking south modest vegetation on waterside slope.

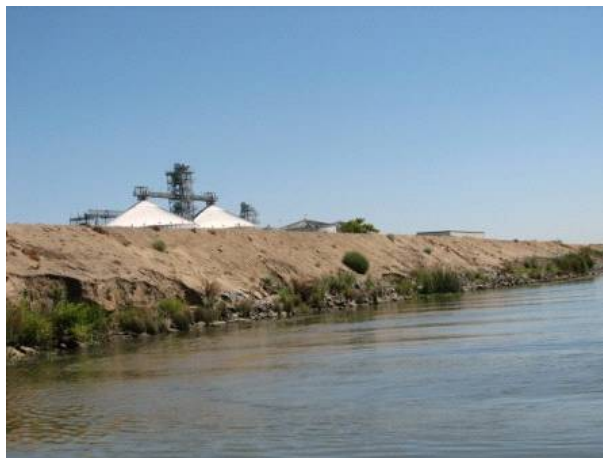
Levee Mile Report Line	3
Start Levee Mile	0.21
End Levee Mile	0.25
Location	Water Side
Category	Supplemental
Item	DWR Erosion Survey

Upstream view of Site. Progressing pocket erosion visible.

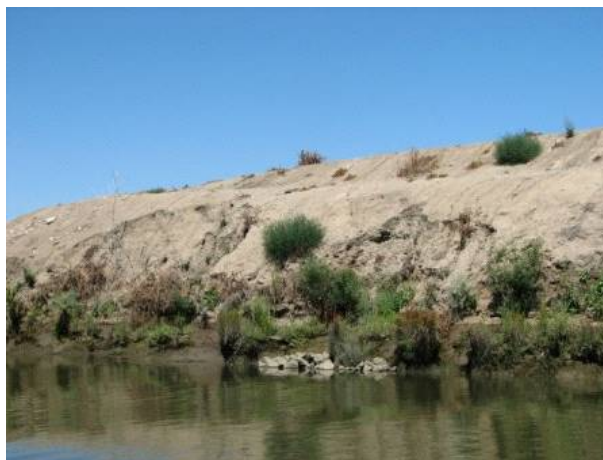
Levee Mile Report Line	3
Start Levee Mile	0.21
End Levee Mile	0.25
Location	Water Side
Category	Supplemental
Item	DWR Erosion Survey

Front view of the site

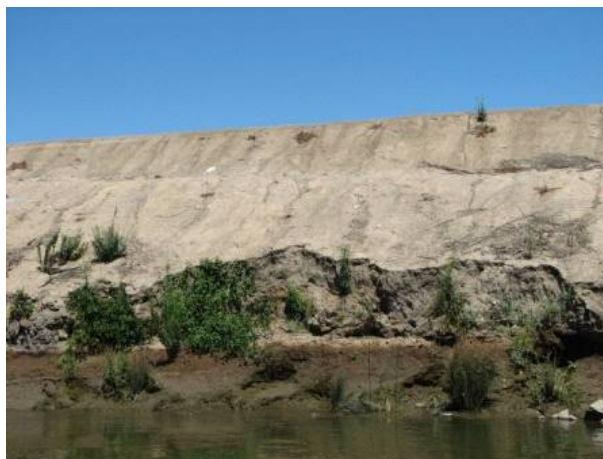
Levee Mile Report Line	3
Start Levee Mile	0.21
End Levee Mile	0.25
Location	Water Side
Category	Supplemental
Item	DWR Erosion Survey

Front view of the site

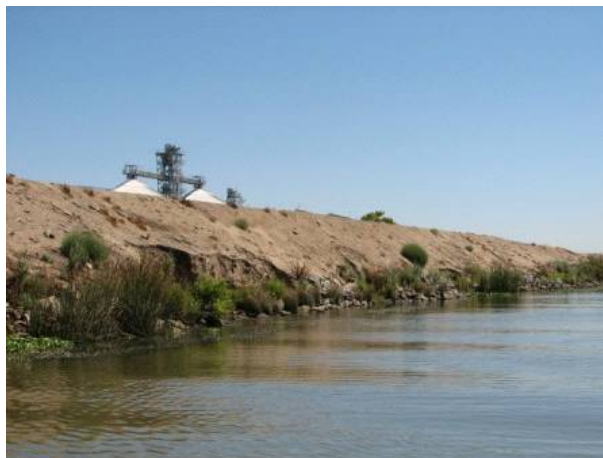
Levee Mile Report Line	3
Start Levee Mile	0.21
End Levee Mile	0.25
Location	Water Side
Category	Supplemental
Item	DWR Erosion Survey

Upstream view of the site

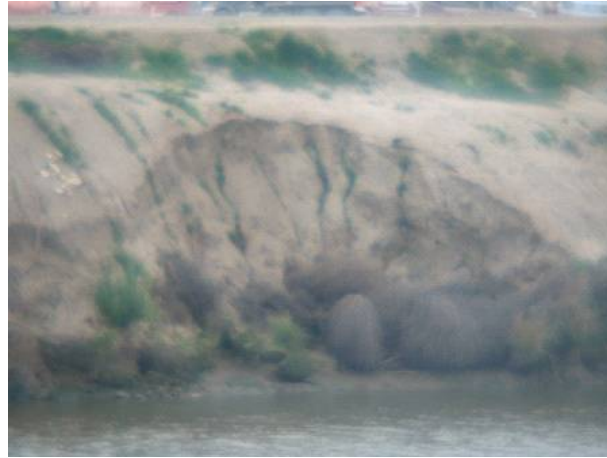
Levee Mile Report Line	4
Start Levee Mile	0.24
End Levee Mile	0.27
Location	Water Side
Category	Earthen Levee
Item	Erosion / Bank Caving

Erosion from LM 0.24 to 0.27

4	0.24	0.27	Earthen Levee	Erosion / Bank Caving	WS	W	Note and monitor erosion site.	37.939430 ° -121.342620 °	37.939430 ° -121.342620 °	6 Y
5	0.30	0.30	Earthen Levee	Erosion / Bank Caving	WS	M	Note and monitor erosion site.	37.939420 ° -121.341643 °	37.939420 ° -121.341643 °	105 Y
6	0.45	0.45	Earthen Levee	Vegetation	WS	M	Remove the wild growth other than native grasses from the levee slopes. Inspector Comments: Remove bamboo on waterside toe.	37.939627 ° -121.338808 °	37.939627 ° -121.338808 °	104 Y
7	0.61	0.61	Earthen Levee	Erosion / Bank Caving	WS	M	Note and monitor erosion site. Inspector Comments: Erosion cause by runoff.	37.939133 ° -121.336100 °	37.939133 ° -121.336100 °	103 Y
8	0.75	0.75	Earthen Levee	Vegetation	LS	M	Elderberries are blocking visibility and flood fight capability.	37.937758 ° -121.334149 °	37.937758 ° -121.334149 °	7 Y
9	0.96	0.96	Earthen Levee	Vegetation	LS	M	Elderberries are blocking visibility and flood fight capability.	37.935990 ° -121.331600 °	37.935990 ° -121.331600 °	2

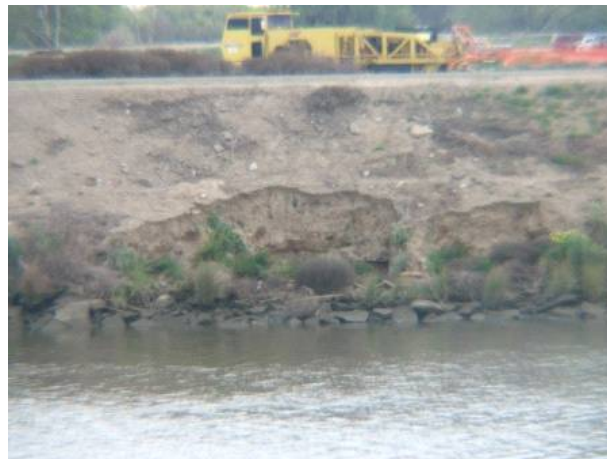
Levee Mile Report Line	4
Start Levee Mile	0.24
End Levee Mile	0.27
Location	Water Side
Category	Earthen Levee
Item	Erosion / Bank Caving

Erosion at LM 0.27

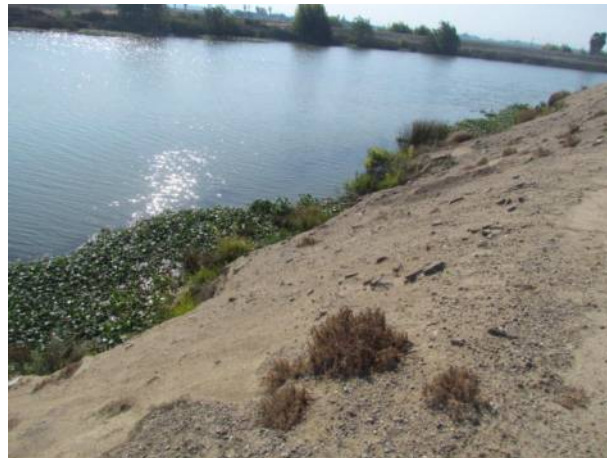
Levee Mile Report Line	5
Start Levee Mile	0.30
End Levee Mile	0.30
Location	Water Side
Category	Earthen Levee
Item	Erosion / Bank Caving

Looking northwest at toe erosion on waterside.

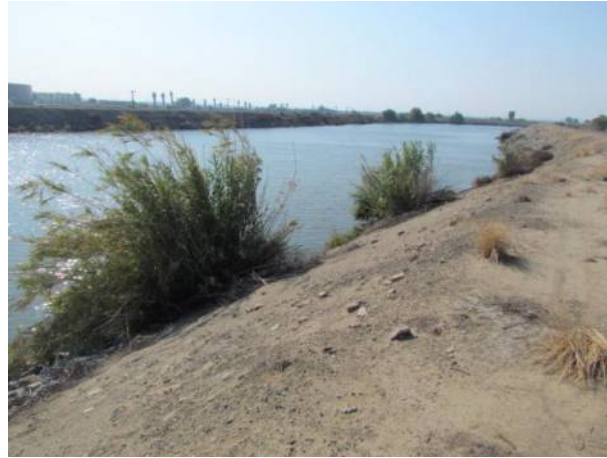
Levee Mile Report Line	6
Start Levee Mile	0.45
End Levee Mile	0.45
Location	Water Side
Category	Earthen Levee
Item	Vegetation

Looking northwest at bamboo on waterside toe.

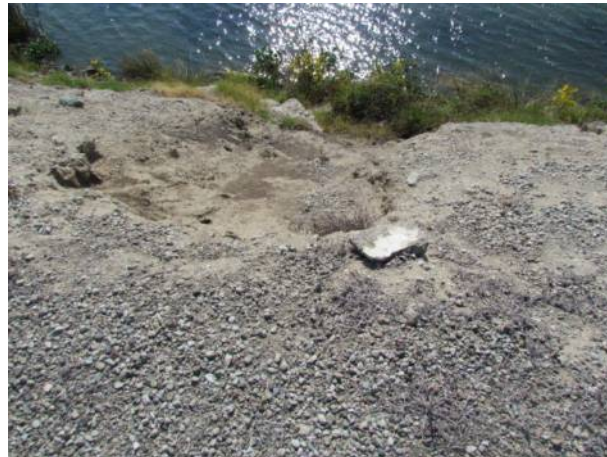
Levee Mile Report Line	7
Start Levee Mile	0.61
End Levee Mile	0.61
Location	Water Side
Category	Earthen Levee
Item	Erosion / Bank Caving

Looking south at erosion on waterside slope.

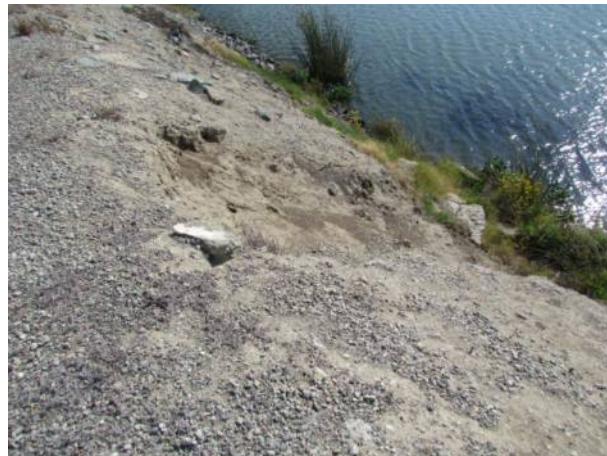
Levee Mile Report Line	7
Start Levee Mile	0.61
End Levee Mile	0.61
Location	Water Side
Category	Earthen Levee
Item	Erosion / Bank Caving

Looking west at erosion on waterside slope.

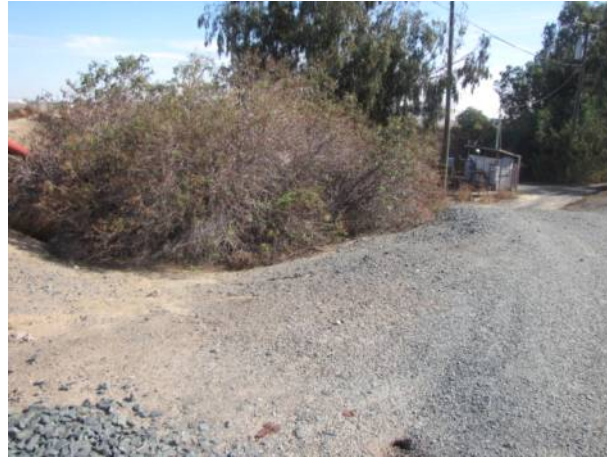
Levee Mile Report Line	8
Start Levee Mile	0.75
End Levee Mile	0.75
Location	Land Side
Category	Earthen Levee
Item	Vegetation

Looking southeast at elderberry on landside slope.

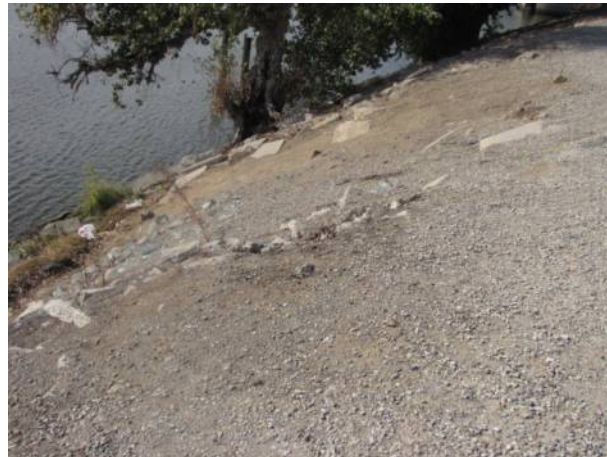
Levee Mile Report Line	14
Start Levee Mile	1.63
End Levee Mile	1.63
Location	Water Side
Category	Earthen Levee
Item	Slope Stability

Looking southwest at minor slope sliding on waterside slope.

LMR No.	Levee Mile		Category	Item	* Location	** Rating	Action/Comment	GPS Latitude/Longitude		Issue No.
	Start	End						Start	End	Photo
14	1.63	1.63	Earthen Levee	Slope Stability	WS	M	Repair slope instability.	37.928208 ° -121.326608 °	37.928208 ° -121.326608 °	12 Y
15	1.64	1.65	Earthen Levee	Slope Stability	LS	M	Repair the levee slope damaged by vehicle traffic and prevent access where possible.	37.928118 ° -121.326338 °	37.927970 ° -121.326007 °	11 Y
16	1.98	1.98	Earthen Levee	Trim / Thin Trees	WS	M	Trim trees to at least five feet above ground level.	37.924055 ° -121.323195 °	37.924055 ° -121.323195 °	99
17	1.99	1.99	Earthen Levee	Encroachments	WS	M	Tree or limb Inspector Comments: Downed trees on waterside slope.	37.923817 ° -121.323130 °	37.923817 ° -121.323130 °	98 Y
18	2.33	2.33	Earthen Levee	Trim / Thin Trees	WS	N	Tree stumps. Inspector Comments: Remove dead tree on waterside toe.	37.920585 ° -121.318850 °	37.920585 ° -121.318850 °	97 Y

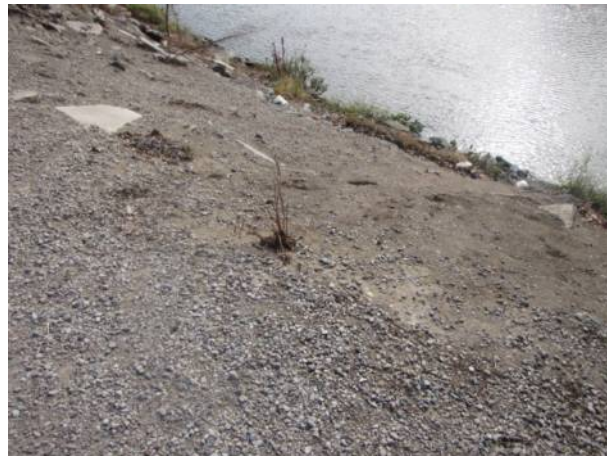
Levee Mile Report Line	14
Start Levee Mile	1.63
End Levee Mile	1.63
Location	Water Side
Category	Earthen Levee
Item	Slope Stability

Looking southeast at minor slope sliding on waterside slope.

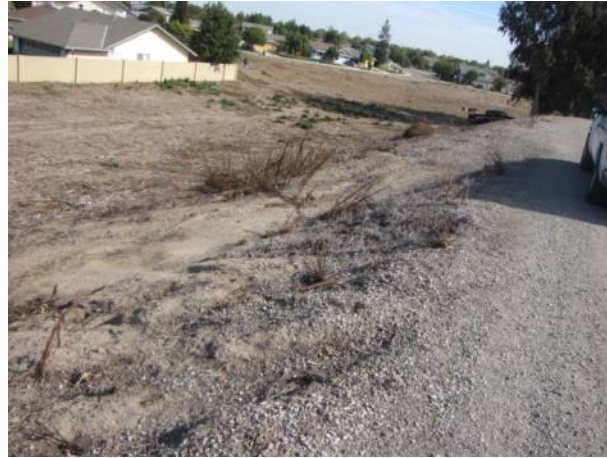
Levee Mile Report Line	15
Start Levee Mile	1.64
End Levee Mile	1.65
Location	Land Side
Category	Earthen Levee
Item	Slope Stability

Looking northeast at minor slope damage on landside slope cause by vehicule traffic.

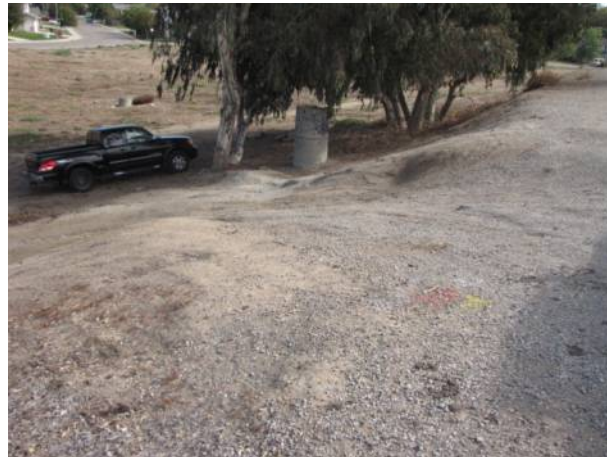
Levee Mile Report Line	15
Start Levee Mile	1.64
End Levee Mile	1.65
Location	Land Side
Category	Earthen Levee
Item	Slope Stability

Looking northeast at slope damage on landside slope cause by vehicle traffic.

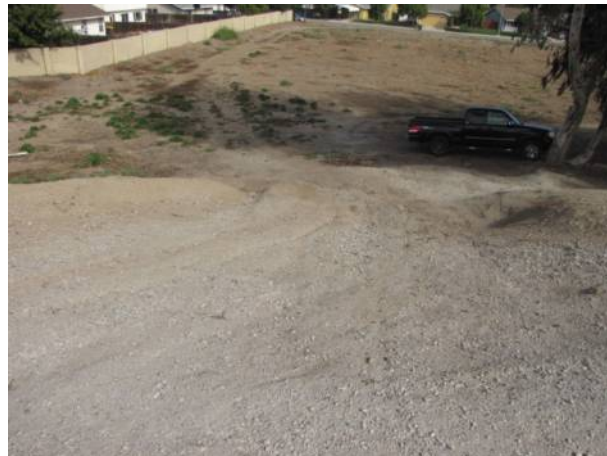
Levee Mile Report Line	15
Start Levee Mile	1.64
End Levee Mile	1.65
Location	Land Side
Category	Earthen Levee
Item	Slope Stability

Looking east at slope damage on landside slope.

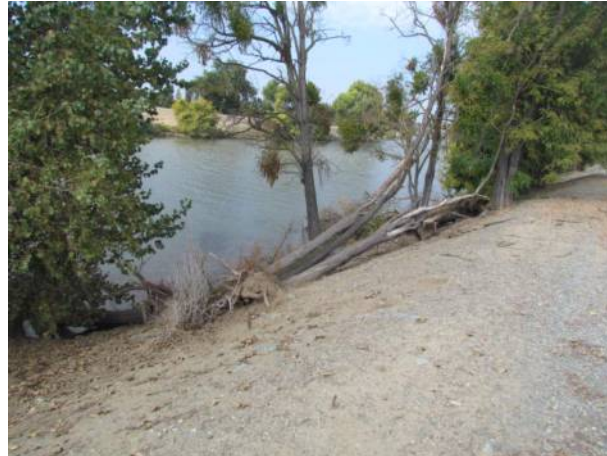
Levee Mile Report Line	17
Start Levee Mile	1.99
End Levee Mile	1.99
Location	Water Side
Category	Earthen Levee
Item	Encroachments

Looking northwest at downed tree on waterside slope.

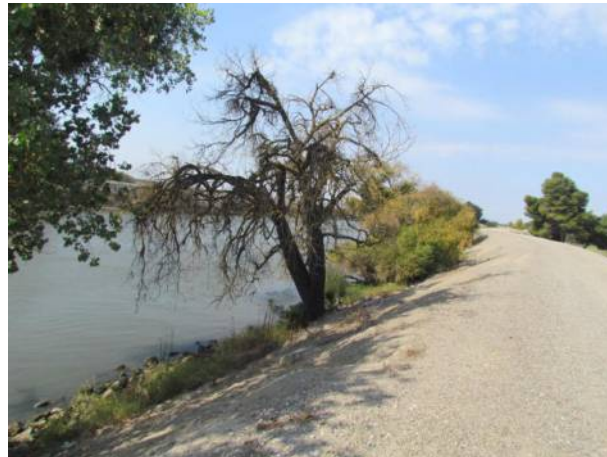
Levee Mile Report Line	18
Start Levee Mile	2.33
End Levee Mile	2.33
Location	Water Side
Category	Earthen Levee
Item	Trim / Thin Trees

Looking northeast at dead tree on waterside toe.

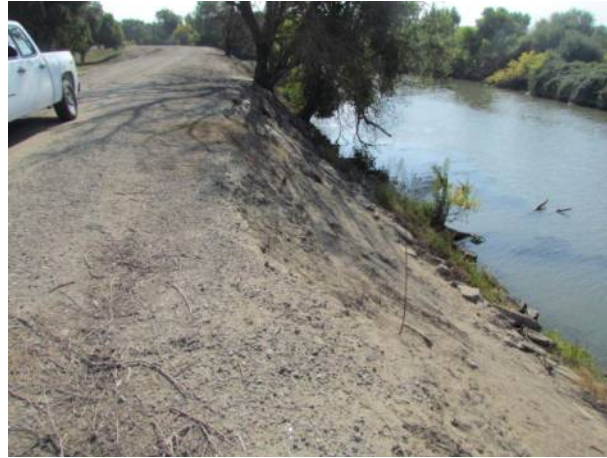
Looking west at waterside slope erosion.

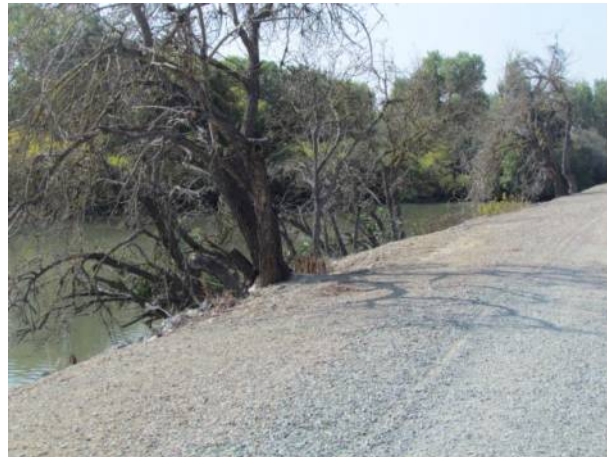
Levee Mile Report Line	3
Start Levee Mile	0.12
End Levee Mile	0.15
Location	Water Side
Category	Earthen Levee
Item	Trim / Thin Trees

Looking northwest at dead trees on waterside slope.

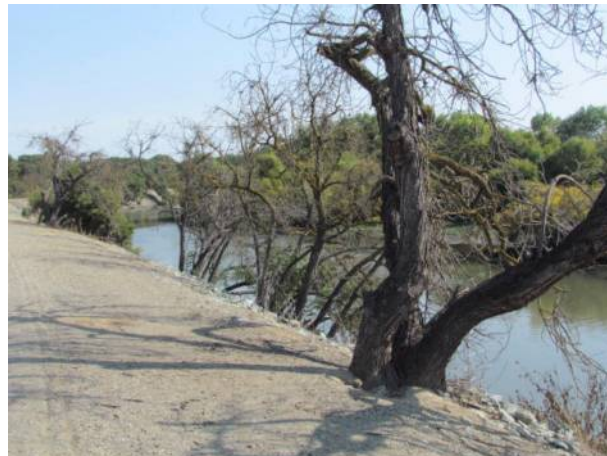
Levee Mile Report Line	3
Start Levee Mile	0.12
End Levee Mile	0.15
Location	Water Side
Category	Earthen Levee
Item	Trim / Thin Trees

Looking southwest at dead trees on waterside slope.

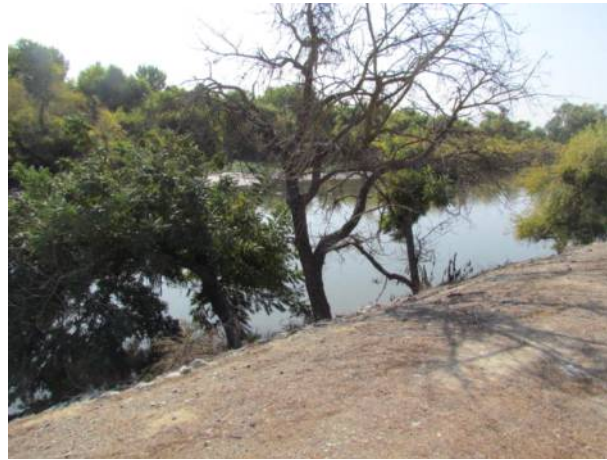
Looking east at dead tree on waterside slope.

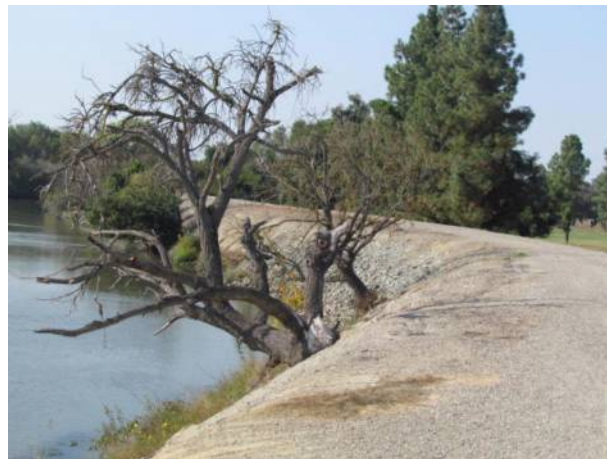
Levee Mile Report Line	7
Start Levee Mile	0.36
End Levee Mile	0.36
Location	Water Side
Category	Earthen Levee
Item	Trim / Thin Trees

Looking northwest at dead tree on waterside slope.

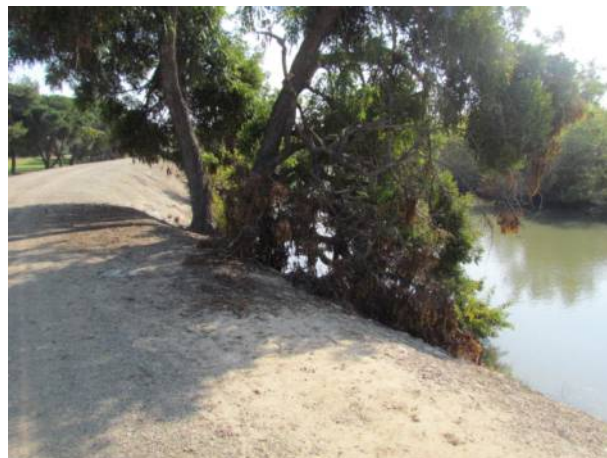
Levee Mile Report Line	10
Start Levee Mile	0.48
End Levee Mile	0.48
Location	Water Side
Category	Earthen Levee
Item	Encroachments

Looking southeast at downed tree limb on waterside slope.

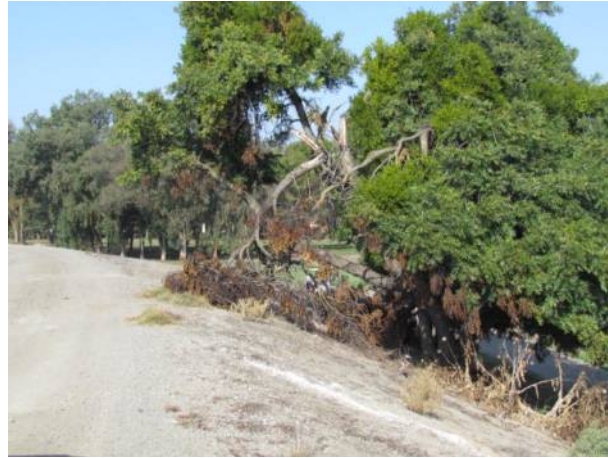
Looking northwest at downed tree limbs on landside slope.

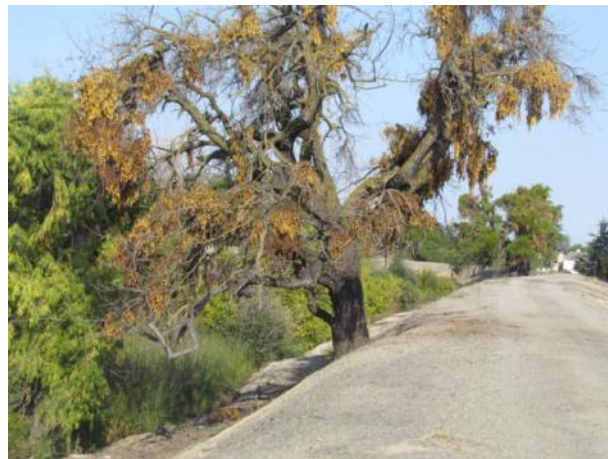
Levee Mile Report Line	15
Start Levee Mile	0.89
End Levee Mile	0.89
Location	Water Side
Category	Earthen Levee
Item	Trim / Thin Trees

Looking northwest at dead tree on waterside slope.

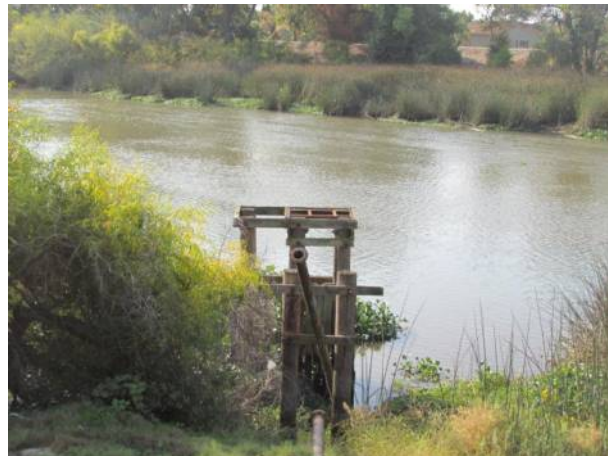
Levee Mile Report Line	16
Start Levee Mile	1.13
End Levee Mile	1.13
Location	Water Side
Category	Earthen Levee
Item	Encroachments

Looking southwest at wooden pump stand in channel.

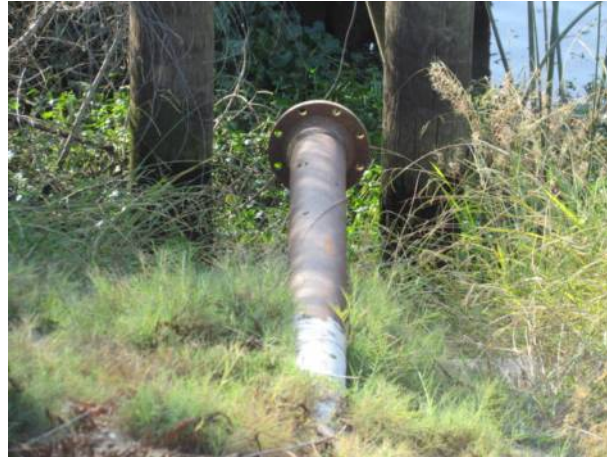
Looking south at 4-6" pipe on waterside slope.

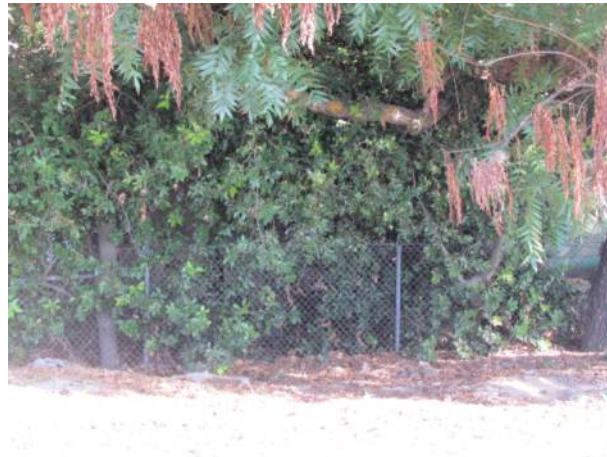
Levee Mile Report Line	18
Start Levee Mile	1.13
End Levee Mile	1.13
Location	Land Side
Category	Earthen Levee
Item	Trim / Thin Trees

Looking northeast at dense vegetation inside fenced area near pump station on landside toe.

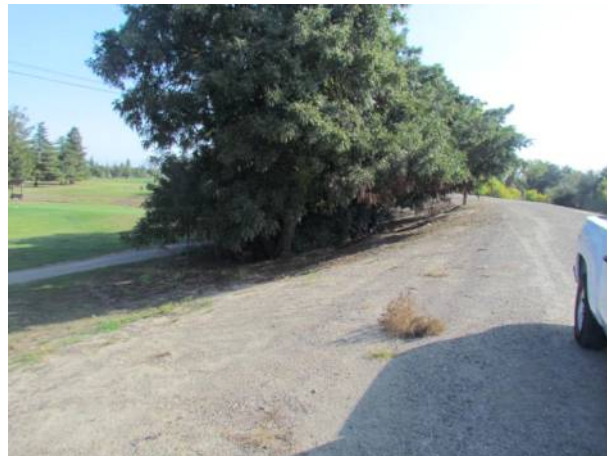
Levee Mile Report Line	18
Start Levee Mile	1.13
End Levee Mile	1.13
Location	Land Side
Category	Earthen Levee
Item	Trim / Thin Trees

Looking east at dense vegetation near pump station on landside toe.

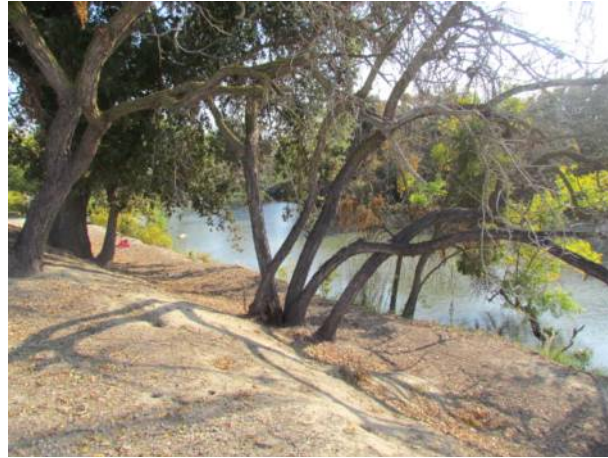
Looking southwest at several dead trees on waterside slope.

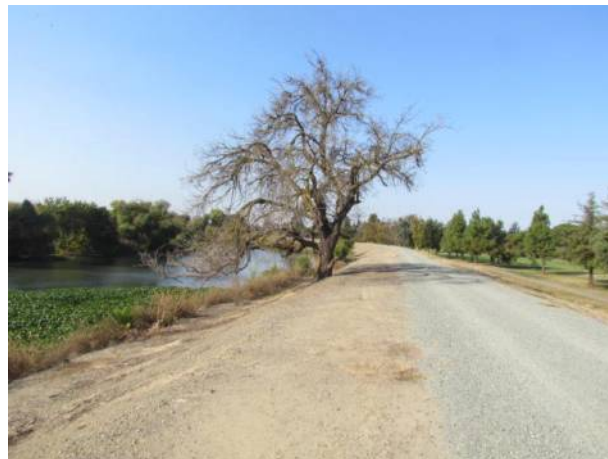
Levee Mile Report Line	24
Start Levee Mile	1.44
End Levee Mile	1.44
Location	Water Side
Category	Earthen Levee
Item	Trim / Thin Trees

Looking east at dead tree on waterside slope.

24	1.44	1.44	Earthen Levee	Trim / Thin Trees	WS	N	Tree stumps. Inspector Comments: Dead tree on waterside slope should be removed.	37.918433 ° -121.297213 °	37.918433 ° -121.297213 °	62 Y
25	1.47	1.52	Earthen Levee	Encroachments	LS	PO	Fences	37.918440 ° -121.296707 °	37.918517 ° -121.295763 °	6 Y

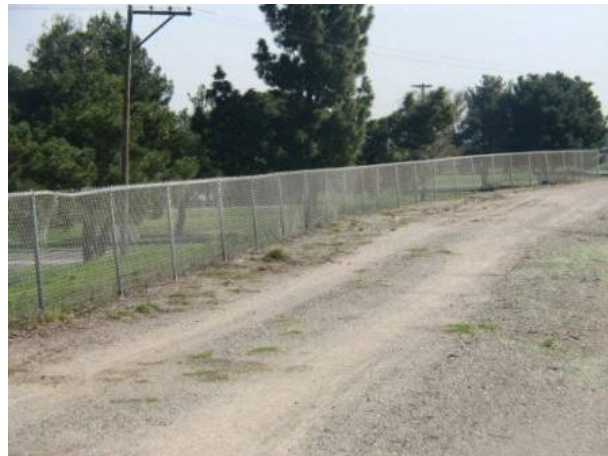
Levee Mile Report Line	25
Start Levee Mile	1.47
End Levee Mile	1.52
Location	Land Side
Category	Earthen Levee
Item	Encroachments

Fence at landside shoulder from LM 1.47 to 1.52

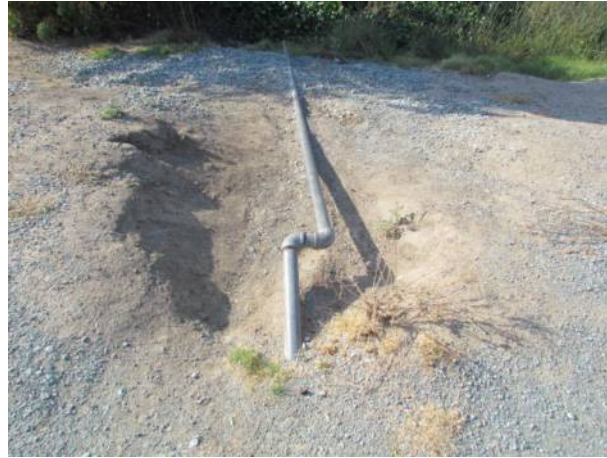
Looking south at 3" pipe on waterside slope.

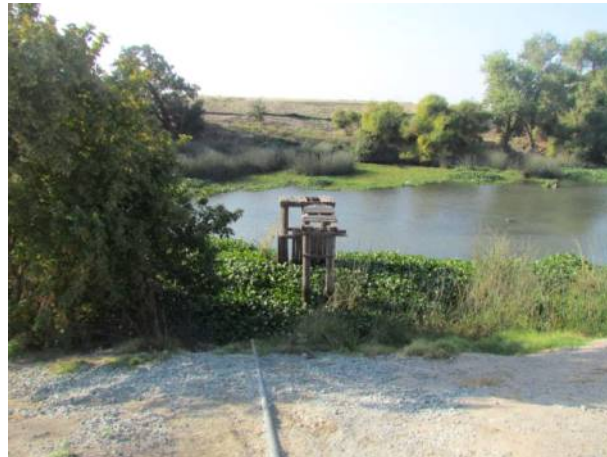
Levee Mile Report Line	27
Start Levee Mile	1.55
End Levee Mile	1.55
Location	Water Side
Category	Earthen Levee
Item	Encroachments

Looking southwest at wooden pump stand in channel.
